Common-Cause Failure Event Insights

Circuit Breakers

NUREG/CR-6819, Vol. 4
INEEL/EXT-99-00613

Common-Cause Failure Event Insights Volume 4 Circuit Breakers

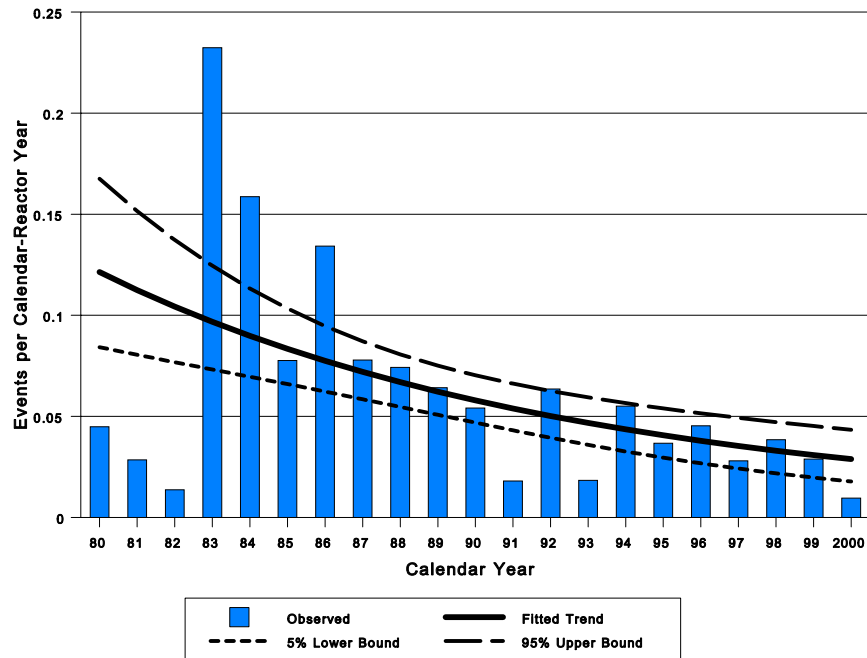
Figure ES-1. Trend for all circuit breaker CCF events. The decreasing trend is statistically significant with a p-value = 0.0001.

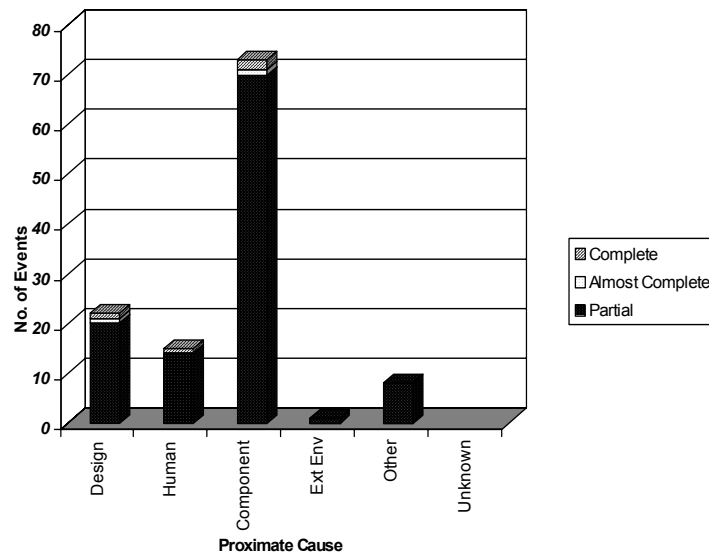
Figure ES-2. Proximate cause distribution for all circuit breaker CCF events.

Proximate Cause. As shown in Figure ES-2, the leading proximate cause group was Internal to Component and accounted for 61 percent of the total. Design/Construction/Installation/Manufacture Inadequacy accounted for about 18 percent of the total events. The Operational/Human error cause group accounted for 13 percent of the total events. There were eight events attributed to the Other cause category. Although the Internal to Component cause group had the largest fraction of the events, only three percent were Complete failures.

The Internal to Component proximate cause category is the most likely for the circuit breakers and encompasses the malfunctioning of hardware internal to the component. Circuit breaker failure due

to internal causes are most likely the result of phenomena such as dirt and dust, hardening of lubricants, aging, normal wear, and binding. Generally, these failures are thought of as being preventable by more frequent maintenance.

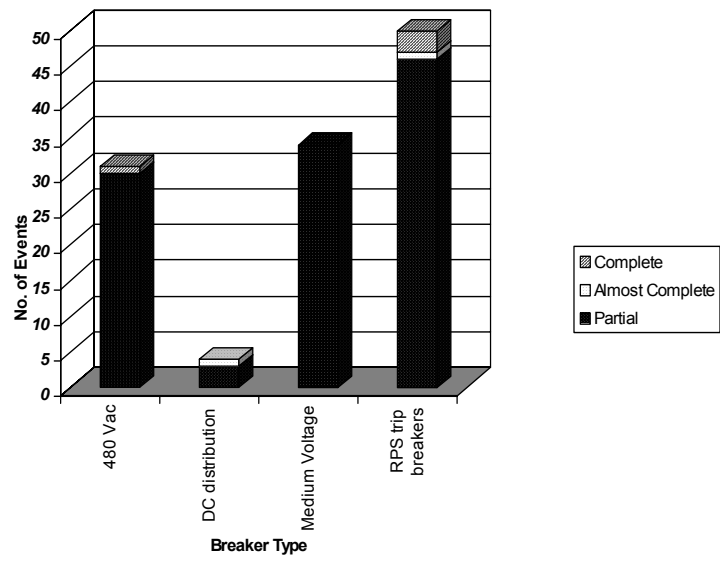
Figure ES-3. Circuit breaker type distribution for all circuit breaker CCF events.

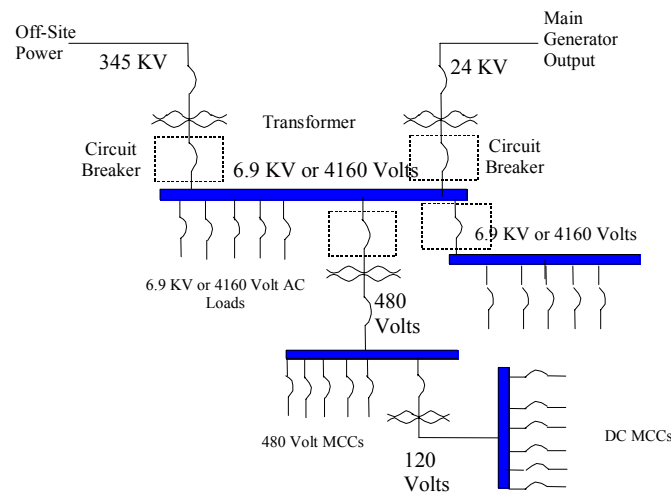
Figure 2-1. Generic distribution system.

The Medium Voltage circuit breakers considered here are feeder circuit breakers to smaller electrical distribution centers (480 Vac motor control centers), circuit breakers between two 4160 volts-ac (Vac) busses, and the feeder circuit breakers from off-site power. Circuit breakers, which supply power to 4160 Vac and 6.9 kVac busses, as well as circuit breakers supplying loads from the 4160 Vac and 6.9 kVac busses, were also considered. Circuit breakers that supply individual components (e.g., safety injection pumps) are not included in this study, but are included in the component studies as a part of the individual component. Circuit breakers used to supply power from an emergency diesel generator to a 4160-volt bus are specifically excluded and are considered under the separate study of emergency diesel generators. Figure 2-1 shows a typical simplified ac power distribution system. The circuit breakers considered in this study are shown in boxes.

Included within the 480 Vac circuit breaker type are the circuit breakers located at the motor control centers (MCC) and the associated power boards that supply power specifically to any 480-volt equipment. The MCCs and the power boards are not included except for the load shedding and load sequencing circuitry/devices, which are, in some cases, physically located within the MCCs. Load shedding of the safety bus and subsequent load sequencing onto the bus of vital electrical loads is considered integral to the 480 Vac circuit breakers function and is therefore considered within the bounds of this study. All instrumentation, control logic, and the attendant process detectors for system initiations, trips, and operational control are included. Batteries were included if failures impacted 480 Vac circuit breakers functional operability. Figure 2-1 shows a typical 480 Vac circuit breaker arrangement.

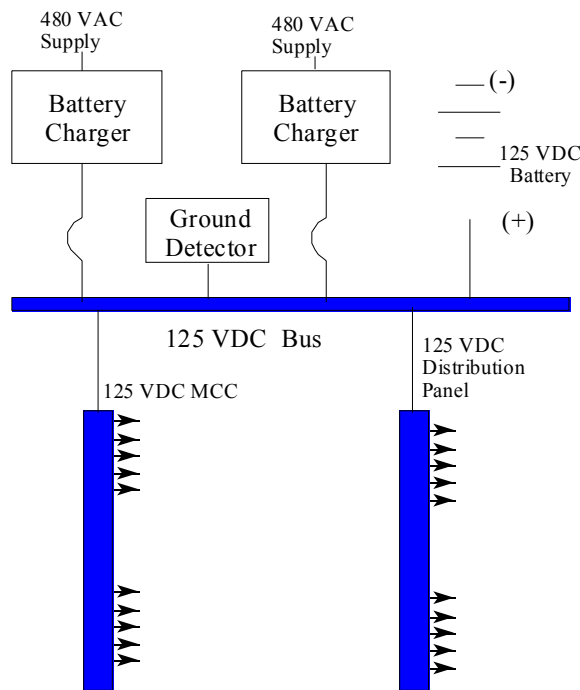
Figure 2-2. Dc power distribution configuration.

Most dc loads are supplied from 125 volt-dc (Vdc) panels through individual distribution circuit breakers, though some plants may have 250 Vdc distribution systems to support dc-powered motor-operated valves or other relatively large dc-powered loads. Multiple trains or divisions are available to ensure dc power is supplied to redundant components. These dc distribution divisions typically number from as few as two to as many as eight depending on the design of the plant. The dc power is normally distributed to the loads from a battery charger in parallel with a battery. The battery charger is usually powered from a Class 1E 480 Vac bus, supplied from off-site power or the emergency diesel generators. In the event power is not available from the normal source, dedicated station batteries supply dc power to the distribution system. A simplified schematic for a typical train or division of dc-power distribution is presented in Figure 2-2.

The dc distribution circuit breakers are normally in the closed position regardless of whether the plant is at power or shutdown. Most of the dc distribution circuit breakers are manipulated locally with only instrumentation available to the control room operator.

The dc circuit breakers have overcurrent protection that is a built-in part of a circuit breaker unit. Most circuit breakers, especially for safety-related equipment applications, provide additional protection by monitoring parameters such as undervoltage, ground faults, and other protection schemes as required for circuit breaker/system protection or the specific safety application. This additional application hardware is generally located external to the circuit breaker and merely utilizes the remote operating features of the circuit breaker. This hardware, as well as the remote operating hardware, is considered integral to the function of the circuit breaker and part of the breaker for failure analysis. It includes all sensing devices, cabling, and components necessary to process the signals and provide control signals to the individual circuit breaker.

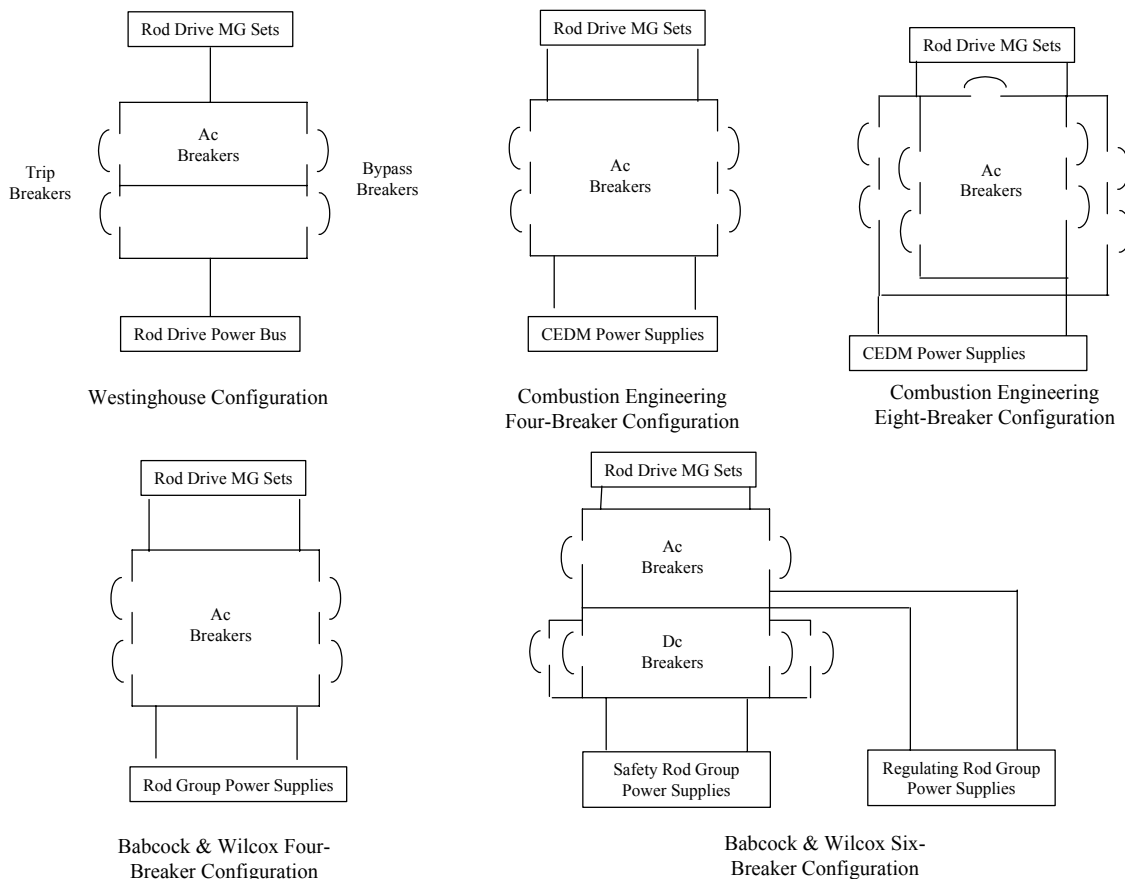
Figure 2-3. Reactor trip breaker configurations.

The reactor trip breakers (RTBs) are part of the pressurized water reactor (PWR) reactor protection system (RPS), and supply power to the control rod drive mechanisms. Both ac and dc circuit breakers are used for the RTBs depending on the RPS design. On a reactor trip signal, the circuit breakers will open, removing power from the control rod drive mechanisms. The control rods will then unlatch and drop into the reactor core due to gravity. Figure 2-3 shows typical RTB arrangements.

The RTB component is defined as the circuit breaker itself, as well the hardware and controls for the individual breakers that enable them to close and remain closed. The rod drive power supplies and RPS system components are not considered part of the RTB.

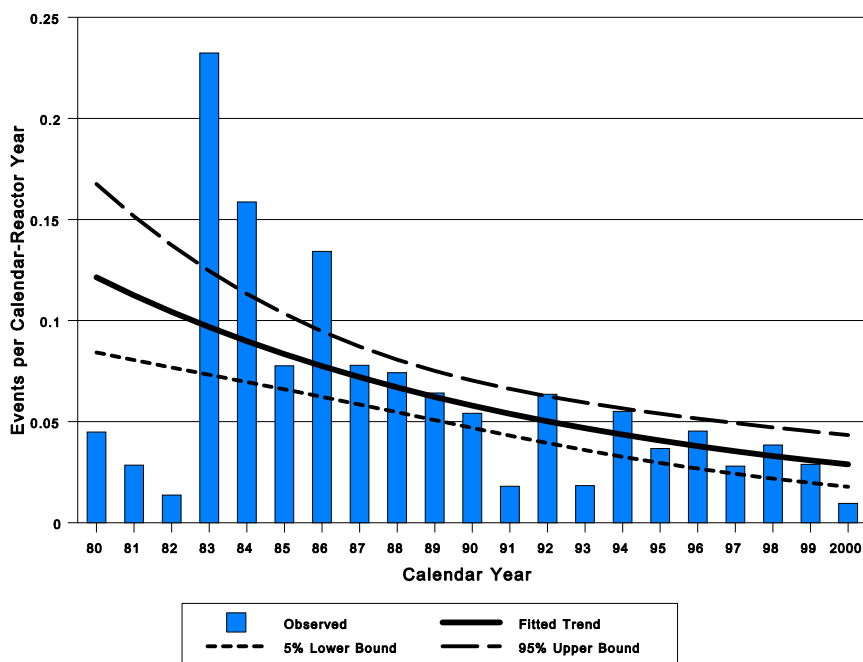
Figure 3-1. Trend for all circuit breaker CCF events. The decreasing trend is statistically significant with a p-value = 0.0001.

Figure 3-1 shows the yearly occurrence rate, the fitted trend, and its 90 percent uncertainty bounds for all circuit breaker CCF events over the time span of this study. The decreasing trend is statistically significant^a with a p-value^b of 0.0001. Based on the review of failure data for this study, the improved maintenance and operating procedures as well as the improved testing and inspection requirements have facilitated the observed reduction of the occurrence of CCF events over the 21 years of experience included in this study.

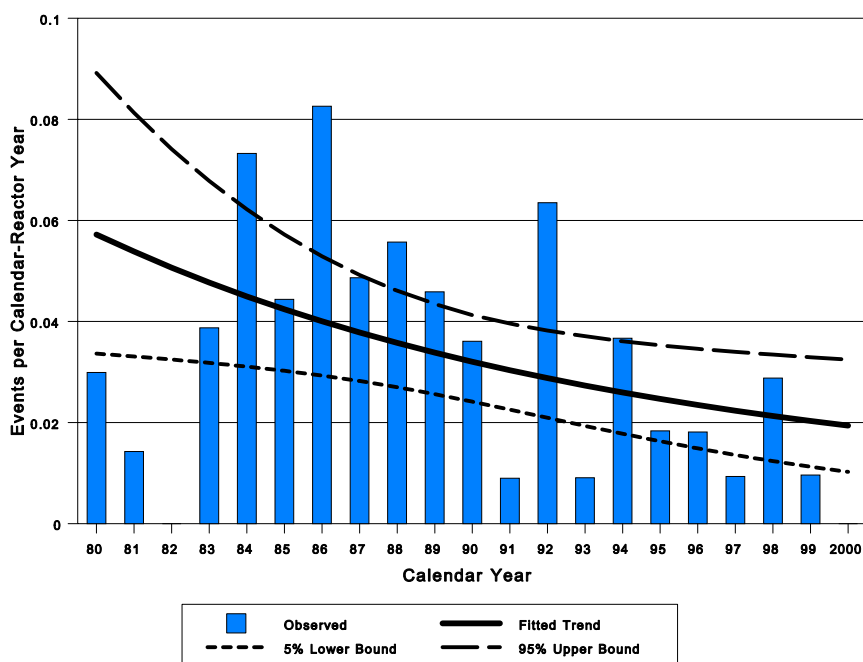
Figure 3-2. Trend for all circuit breaker CCF events for the fail-to-close failure mode. The decreasing trend is statistically significant with a p-value = 0.0099.

Figure 3-2 and Figure 3-3 show similar statistically significant decreasing trends for both the fail-to-close and the fail-to-open failure modes for all circuit breaker CCF events, with p-values of 0.0099 and 0.0001, respectively. Figure 3-2 shows a significant increase after 1983 followed by a noticeable decrease in the number of total failures beginning in 1990. Figure 3-3 shows a large step increase in 1983, followed by a rapid decrease from 1983 through 1987. The increase in circuit breaker unreliability was noted in a study performed for the NRC's Nuclear Plant Aging Research Program (NPAR)⁹. The study noted that this increase was due to utility response to IE Bulletins (IE 83-01 & IE 83-08) that were issued subsequent to the RTB failures at Salem Unit 1 in February 1983. In addition to more frequent and detailed inspections, the IE Bulletins required independent testing of the operation of the undervoltage

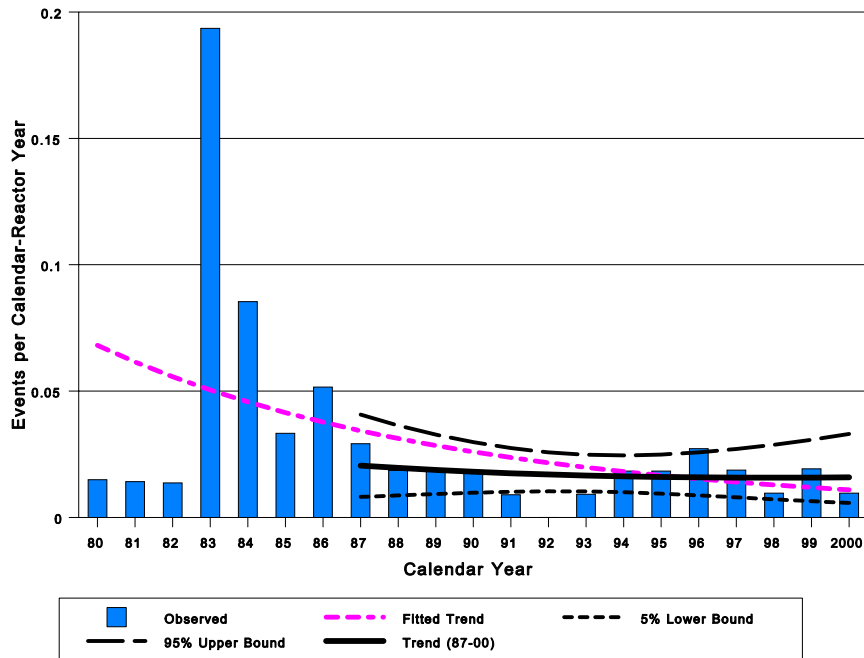
Figure 3-3. Trend for all circuit breaker CCF events for the fail-to-open failure mode. The decreasing trend is statistically significant with a p-value = 0.0001. P-value is 0.6746 for 1987-2000 data.

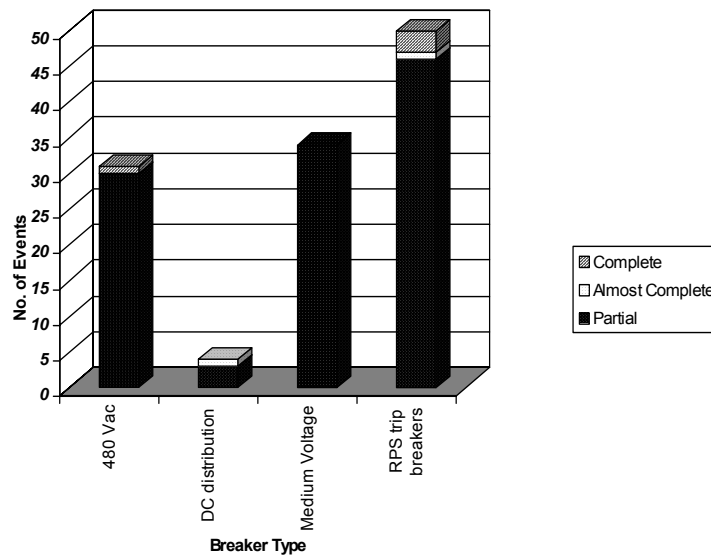
Figure 3-4. Circuit breaker type distribution for all circuit breaker CCF events.

Figure 3-4 shows the distribution of the CCF events by circuit breaker type. The highest number of events occurred in the RPS trip breaker type (50 events or 42 percent). The Complete RTB events are fail-to-open, and all occurred in 1983 at two NPP units. The Medium Voltage (34 events, 29 percent) and 480 Vac circuit breakers (31 events, 26 percent) are also significant contributors. Together, these three circuit breaker types comprise over 97 percent of the circuit breaker CCF events studied. Section 4 of this report provides an in-depth analysis of the CCF events assigned to these circuit breaker types.

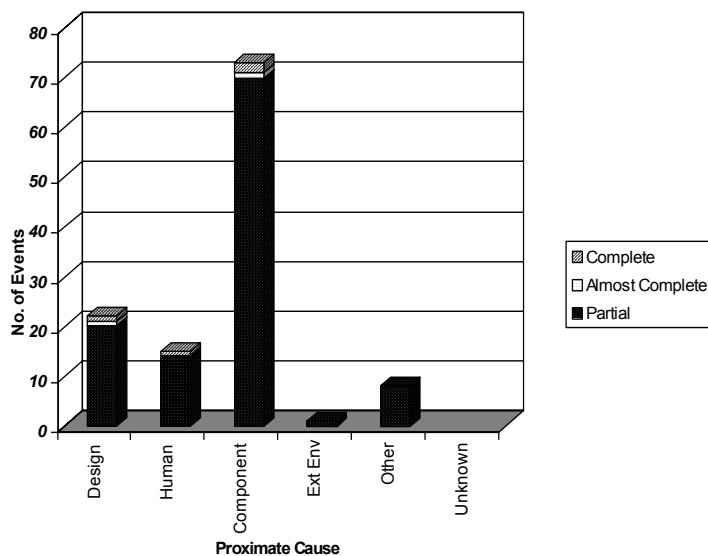
Figure 3-5. Proximate cause distribution for all circuit breaker CCF events.

Figure 3-5 shows the distribution of CCF events by proximate cause. The leading proximate cause was Internal to Component and accounted for about 61 percent of the total events. Design/Construction/Installation/Manufacture Inadequacy faults accounted for 18 percent of the total. Human error accounted for 13 percent of the total events. To a lesser degree, External Environment and the Other proximate cause categories were assigned to the circuit breaker component.

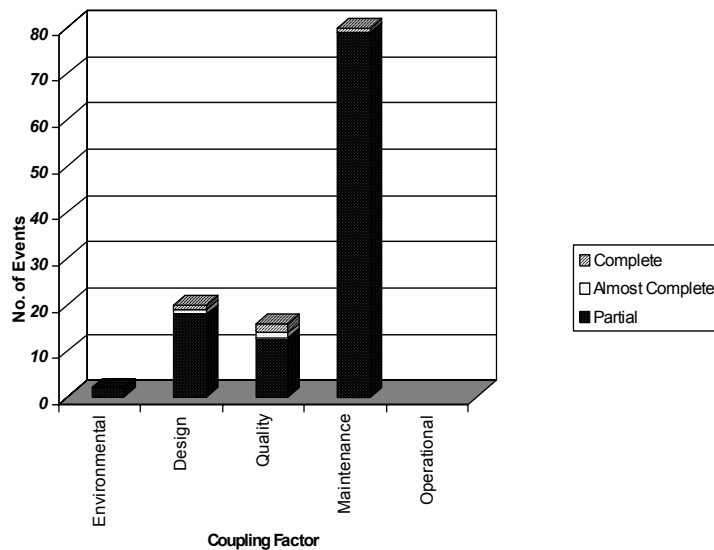
Figure 3-6. Coupling factor distribution for all circuit breaker CCF events.

Closely connected to the proximate cause is the concept of **coupling factor**. A coupling factor is a characteristic of a component group or piece parts that links them together so that they are more susceptible to the same causal mechanisms of failure. Such factors include similarity in design, location, environment, mission, and operational, maintenance, design, manufacturer, and test procedures. These factors have also been referred to as examples of coupling mechanisms, but because they really identify a potential for common susceptibility, it is preferable to think of these factors as characteristics of a common-cause component group. Reference 4 contains additional detail about the coupling factors. Figure 3-6 shows the coupling factor distribution for the events.

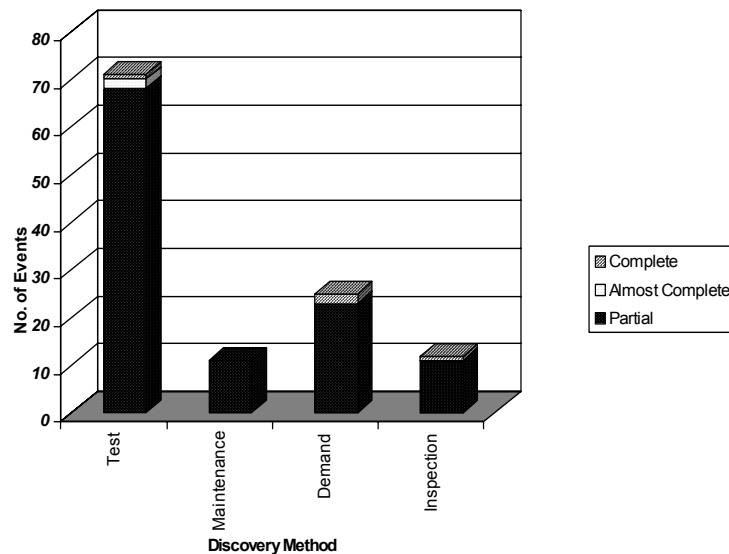
Figure 3-7. Discovery method distribution for all circuit breaker CCF events.

Figure 3-7 shows the distribution of how the events were discovered or detected. Testing accounts for 71 events, (60 percent), Demand for 25 events (21 percent), Maintenance for 11 events (9 percent), and Inspection for 12 events (10 percent). The importance of Testing indicates the success of testing in detecting common-cause failures. Testing is designed to detect faults before they occur. The testing program has shown that it is successful in accomplishing this goal.

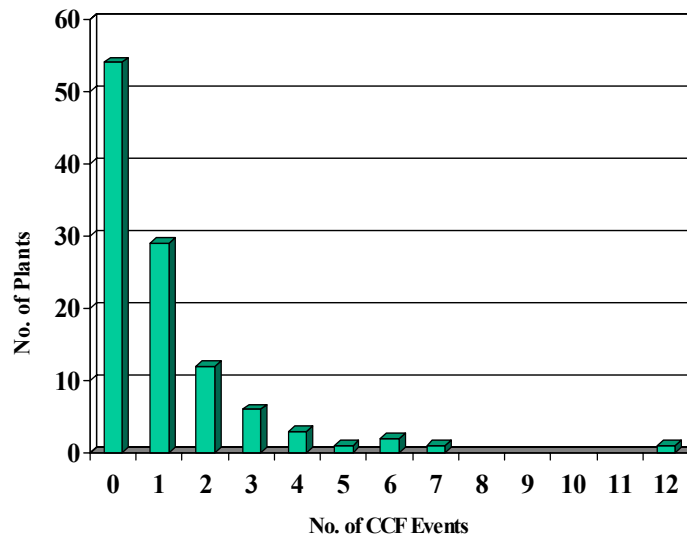
Figure 3-8. Distribution of NPP units experiencing a multiplicity of CCFs for all circuit breaker CCF events.

Figure 3-8 shows the distribution of breaker CCF events among the NPP units. The data are based on 109 NPP units represented in the insights CCF studies. The largest contribution (76 percent) consists of NPP units with either zero or one CCF event. This may indicate that the majority of the NPP units have maintenance and testing programs to identify possible circuit breaker CCF events and work towards preventing either the first event or any repeat events. Seventy-four percent of the total circuit breaker CCF events occurred at 51 of the NPP units.

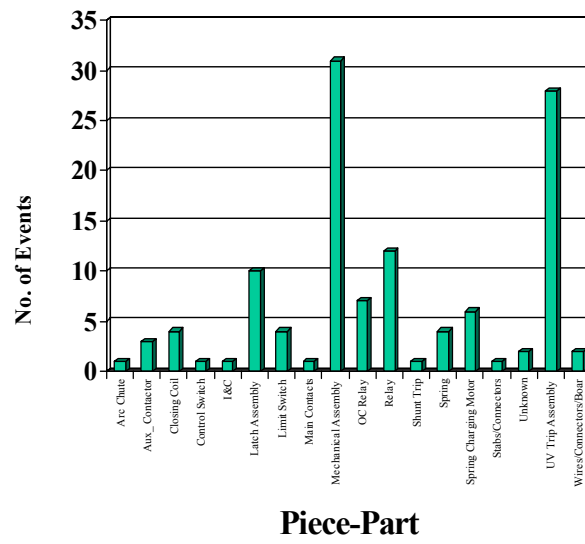
Figure 3-9. Distribution of the failed piece-parts for all circuit breaker CCF events.

Figure 3-9 shows the distribution of the failed piece-parts for all breaker types. The mechanical assembly had 31 events (26 percent). The mechanical assembly was identified for all breaker types. Most of these events were coupled by inadequate maintenance. The UV trip assembly had 28 events (24 percent). The UV trip assembly was identified mostly for the RPS trip breakers. Table A-4 in Appendix A presents the entire circuit breaker data set, sorted by the piece-part. This table can be referred to when reading the following discussions to see individual events described.

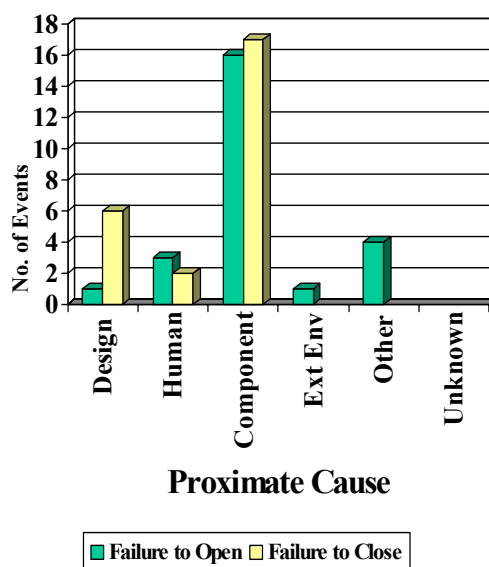
Figure 4-1. Distribution of proximate causes for the RPS trip breaker type.

Fifty circuit breaker CCF events affected the RPS Trip type circuit breaker (see Table B-1 in Appendix B, items 70–119). Figure 4-1 through Figure 4-3 show selected distributions graphically. Half of the RTB CCF events (25) were due to problems with the undervoltage (UV) trip assemblies. Table 4-3 contains a summary of these events by proximate cause group and failure. Figure 4-1 shows that the most likely proximate cause group was Internal to the Component.

The Internal to Component proximate cause group had 33 events (66 percent) of which two were Complete and one was Almost Complete (see Table B-1 in Appendix B, items 78 –110). Affected piece parts included the undervoltage trip assembly, the mechanical operating assembly, and the latch assembly. The vast majority of these events were coupled by inadequate maintenance.

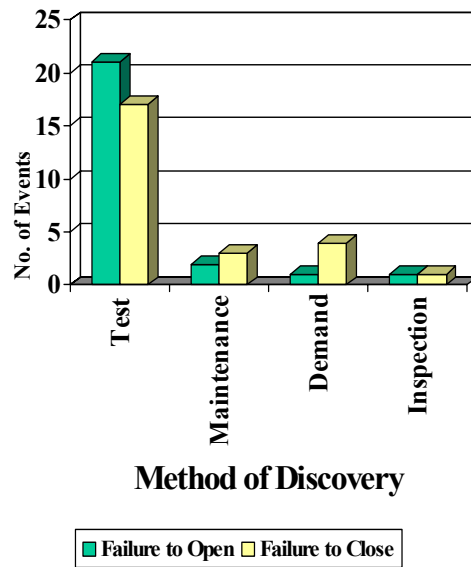
Figure 4-2. Distribution of the method of discovery for the RPS trip breaker type.

Testing was the most likely method of discovery for instrumentation and control circuit breaker events (38 out of the 50 events, 76 percent) as shown in Figure 4-2. The reactor trip breakers are frequently tested. This tends to make testing the most likely method of discovery. Inspection, Maintenance, and Demand make up the rest of the observed discovery methods. The most likely piece part involved in a RTB CCF event was the undervoltage trip assemblies as shown in Figure 4-3.

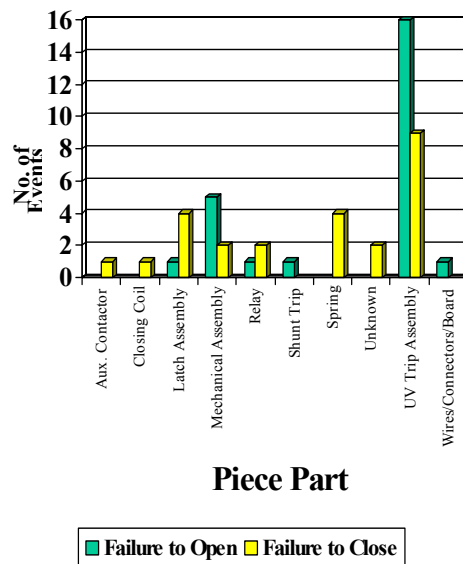
Figure 4-3. Distribution of the affected piece part for the RPS trip circuit breaker type.

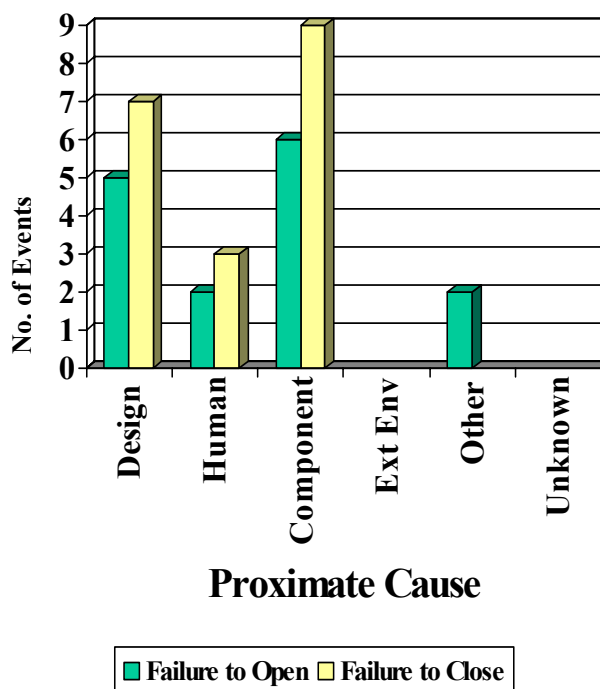
Figure 4-4. Distribution of proximate causes for the Medium Voltage circuit breaker type.

The most likely proximate causes are Internal to Component and Design/Construction/Installation/Manufacture Inadequacy as shown in Figure 4-4. Table 4-5 contains a summary of these events by proximate cause group and degree of failure. None of the Medium Voltage breaker CCF events were complete.

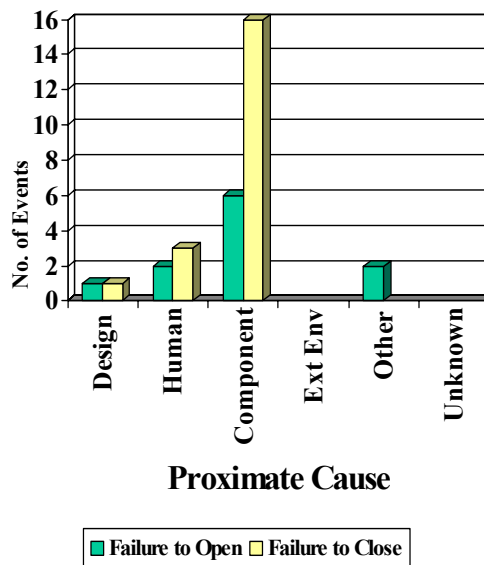
Figure 4-7. Distribution of proximate causes for the 480 Vac circuit breaker type.

The Internal to Component proximate cause group had 22 events (71 percent) of which none were Complete (see Table B-1 in Appendix B, items 3 – 24). Affected piece parts included the mechanical operating assembly, relays, closing coils, latch assemblies, auxiliary contactors, and over-current relays. Almost all of these events were coupled by inadequate maintenance and testing schedules.

The Operational/Human Error proximate cause group contained five events (16 percent) of which none were Complete (see Table B-1 in Appendix B, items 25 – 29). Affected piece parts included the mechanical operating assembly, the main contacts, and the over-current relay. These events were all coupled by either inadequate maintenance, test procedures, or by maintenance staff errors.

The Design/Construction/Installation/Manufacture Inadequacy proximate cause group had two events (6 percent) of which one was Complete (see Table B-1 in Appendix B, items 1 – 2). Affected piece parts included fuses, relays, stab connectors, and trip coils. Most of these events were coupled by shared quality issues related to installation or construction.

The Other proximate cause group had two events, neither of which was complete (see Table B-1 in Appendix B, items 30 – 31). Both events involved out-of-tolerance over-current trip relays.

Thirty-one circuit breaker CCF events affected the 480 Vac circuit breakers (see Table B-1 in Appendix B, items 1–31). Figure 4-7 through Figure 4-9 show selected distributions graphically. The majority of circuit breaker CCF events involving the 480 Vac circuit breaker type were caused by faults internal to the circuit breakers. Of the 31 events, only one was Complete. The coupling factor for almost all of the events (27) was Maintenance. Table 4-6 contains a summary of these events by proximate cause group and degree of failure.
